Re: **Building 52 Engineering Evaluation Report**

Stabilization Evaluation

One River Street
Hastings-on-Hudson, NY

27 May 2011

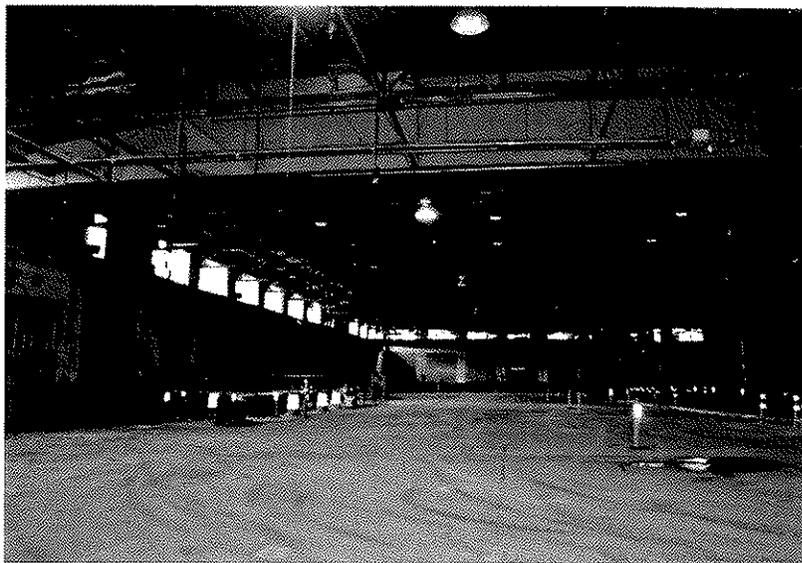
The floor is exposed concrete and based on visual observations appears to be in fair to good condition [photo 1]. There are various trenches that may have housed pipes or rails, which have been filled in with concrete, most likely at a later date than when the slab was poured. [photo 2]. The surface is somewhat uneven across the entire floor. There is an existing pile layout drawing, which led us to assume that the majority of the floor consists of a spanning slab.

Photo 1: Overall interior

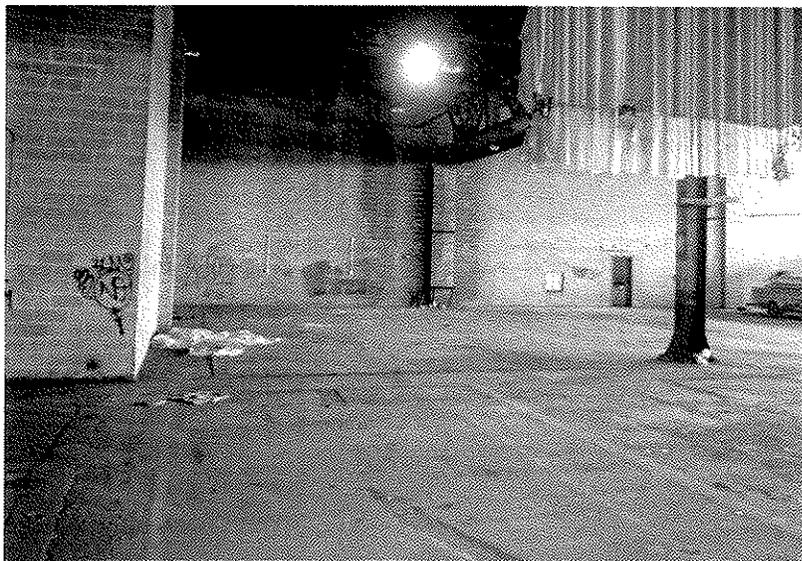
Photo 2: Trenches in floor

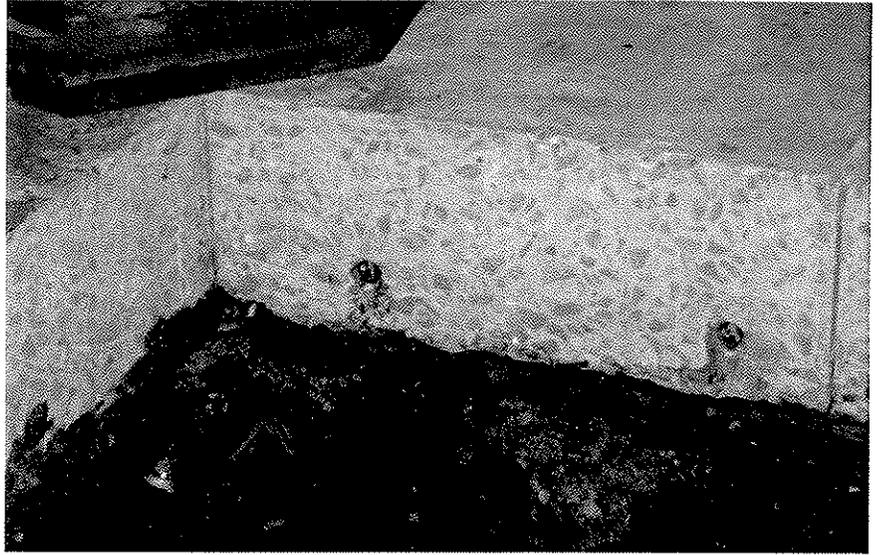
Photo 3 (top): Floor probe #2
cross section with reinforcing

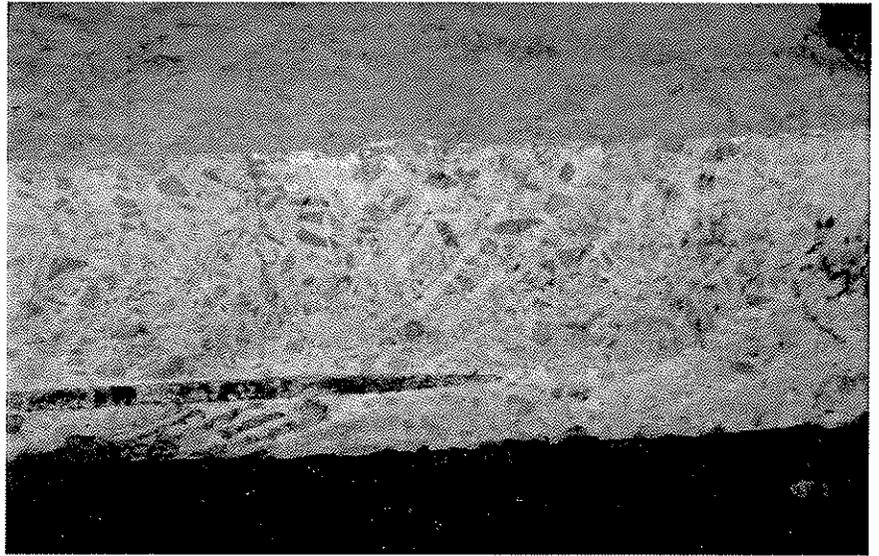
Photo 4 (middle): Floor probe #5
cross section with reinforcing

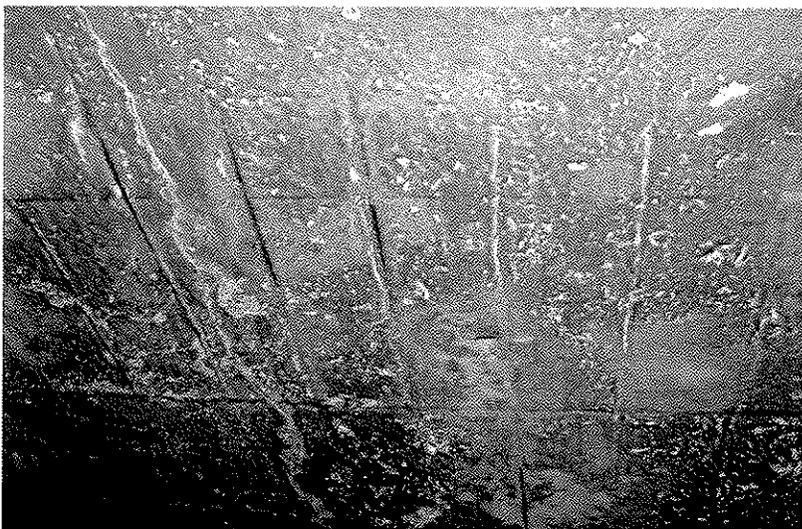
Photo 7: Underside of roof slab - mesh close to surface and corroded

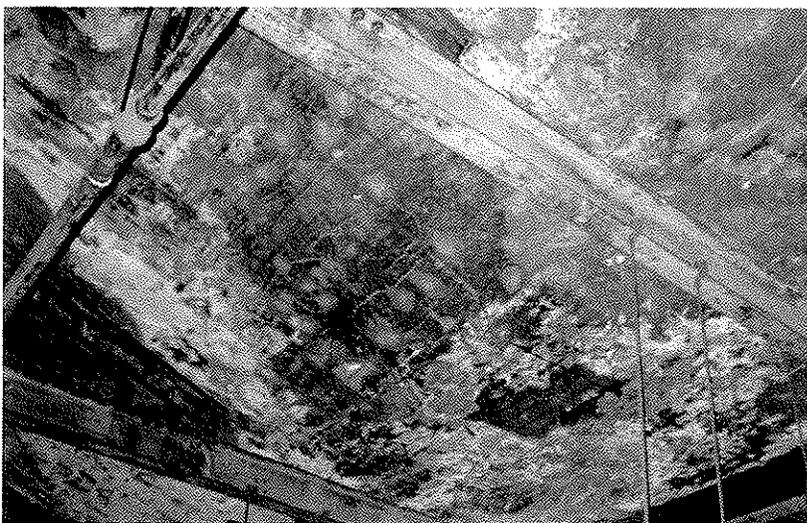
Photo 8: Underside of roof slab - corroded mesh

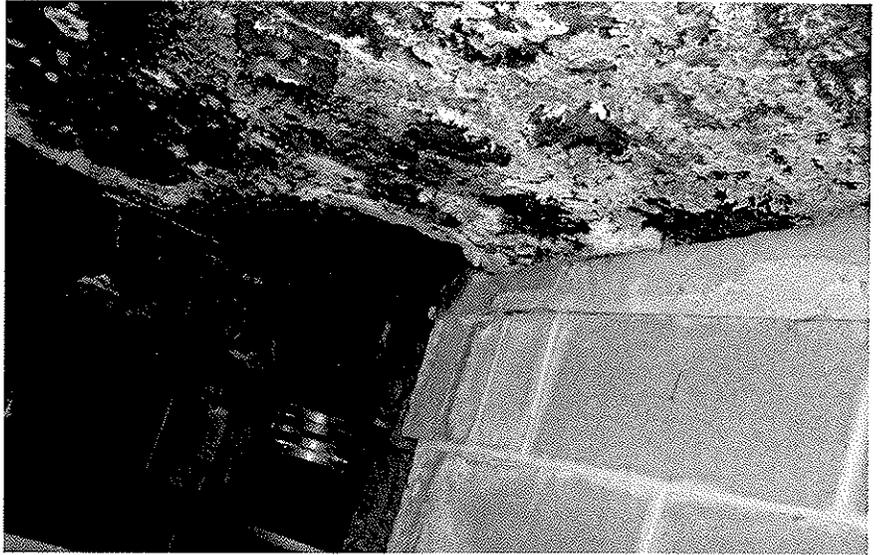
Photo 9 (top): Underside of roof slab - moisture by drain

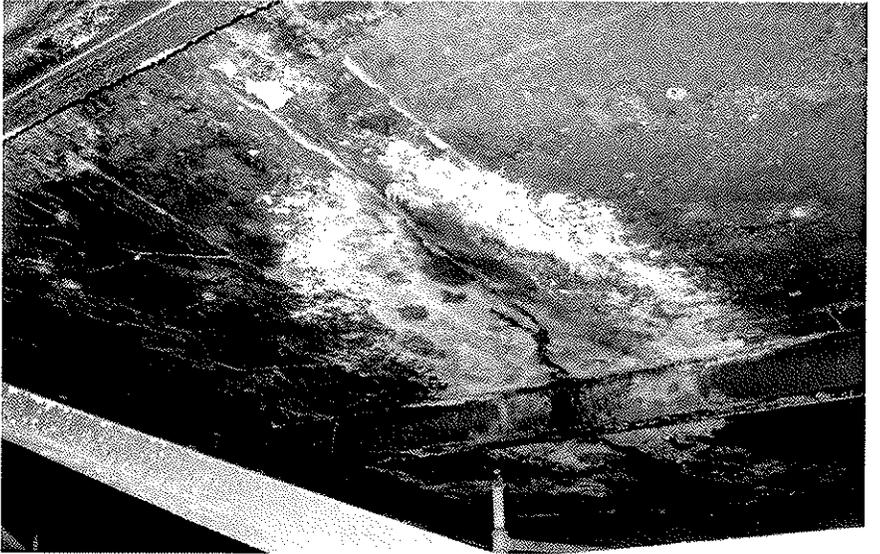
Photo 10 (middle): Crack in roof slab

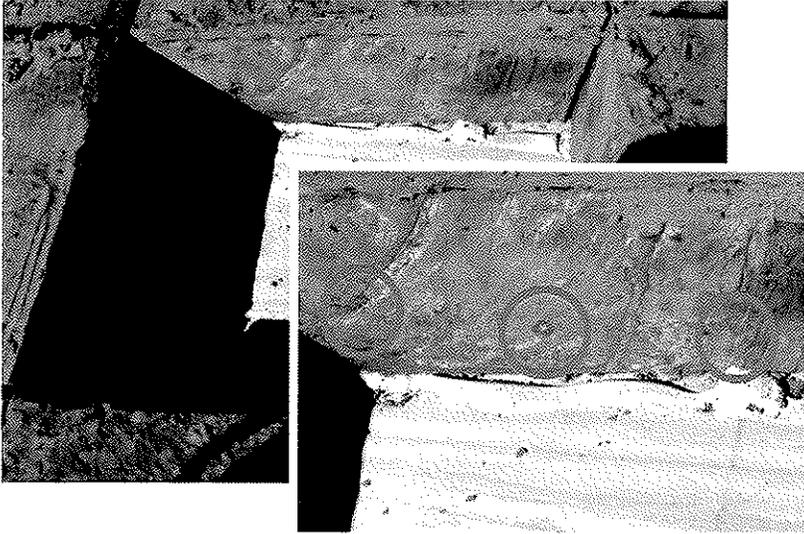
Photo 12: Roof probe #6 - cross section with reinforcing

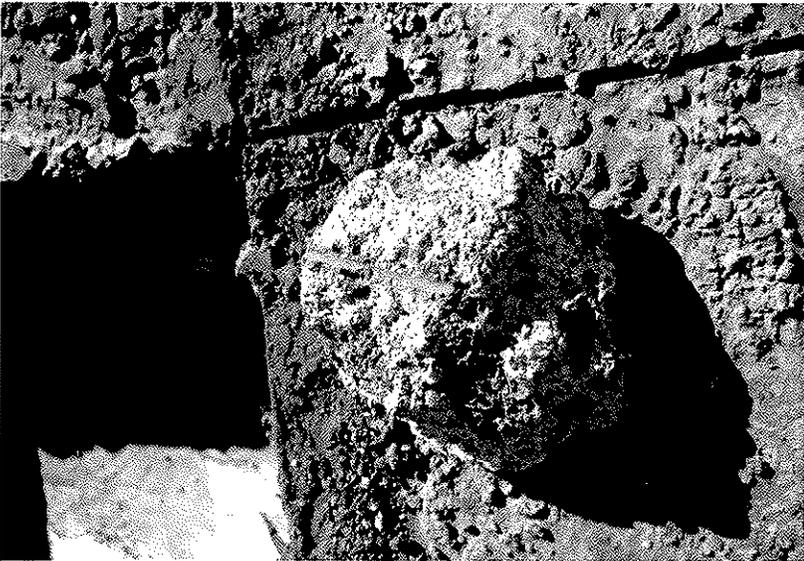
Photo 13: Roof probe #2 - corrosion on reinforcing

probe 2 had reinforcing that had moderate corrosion and rust staining of the concrete around the mesh. This was not surprising as this probe was performed near an existing roof drain where other visual observations had determined that water damage had been occurring for some time [photo 13].

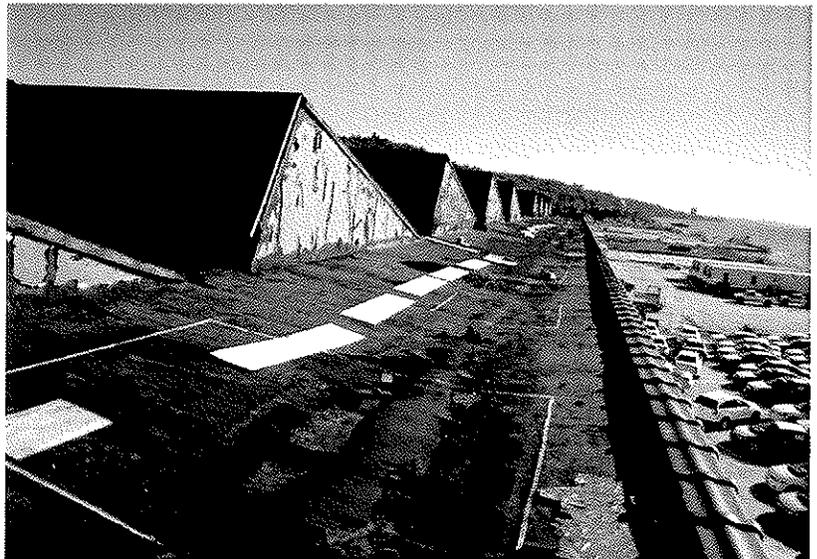
Photo 14: Overall of roof looking south

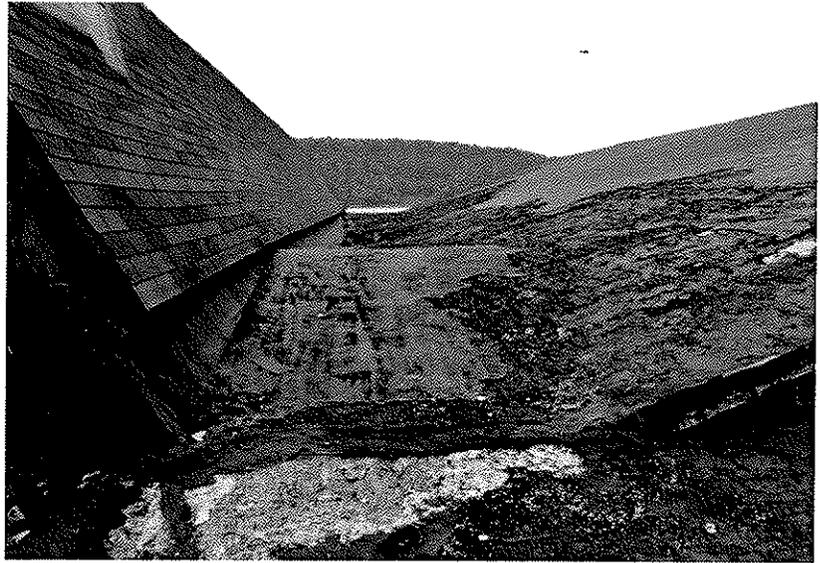
The roof is in poor condition, the membrane partially blown off at several locations. Failure of the top layer of the membrane occurs across extensive areas near the middle of the building, from column lines 19 to 26 [photo 15], and at the southern end of the building. At a select number of locations, the concrete deck is completely exposed. There are hundreds of square feet of various sheet and trowel applied roof patches from multiple attempts to address localized membrane failures. These patches are primarily at low slope roof areas surrounding the monitors. Standing water was observed during an October 2010 site visit, when no precipitation had occurred during the previous 24 hours. Presently, there are several active leaks (these leaks, observed at the interior, are un-documented).

Photo 15: Roof membrane failure, column line 19, looking west.

The existing roof membrane, including perimeter and penetration flashings, cannot be effectively repaired. Roof replacement is mandatory. One approach to roof replacement first requires the total removal of the existing membrane system. This would then allow a detailed inspection and repair of the concrete decking before application of a new roof system. However, this approach is very expensive and is not required in order to stabilize the roof enclosure.

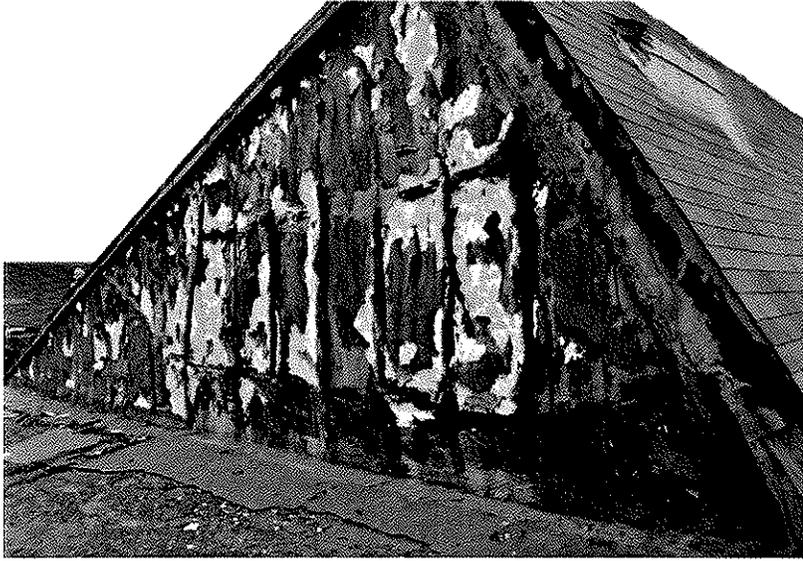
The triangular end walls of the monitors are in very poor condition, deteriorated beyond repair. During a site visit, the construction of the side walls was observed through a hole that was formed by a recently fallen piece of cement plaster. These walls consist of 1 ½ inches x 1 inch "T"-shaped vertical light metal-framing members, spaced approximately 22 inches on center. Expanded metal lath, fastened with metal wire ties, had a 1 ½ inch application of cement plaster on each side; total wall thickness of approximately 3 inches. Various coating remnants observed on the exterior cement plaster surface suggest that at some time the walls were white. The presence of a black asphaltic top coat is indicative of a previous attempt to limit water infiltration. More recently, cracks have been dressed with trowel grade roof patching mastic.

Photo 17: Cement plaster side wall at roof monitor

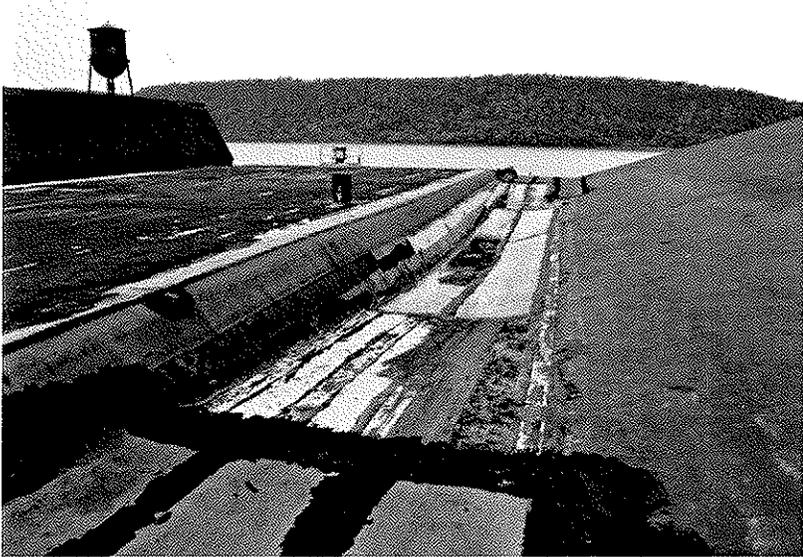
The roof monitor between column lines 22-25, including the concrete deck, much of the curb, and associated supporting steel, no longer exists. The monitor has been replaced by low slope roof on metal deck [photo 18]. The roof membrane over the metal deck differs from most of the building. At this area, the deteriorated membrane appears to be some sort of a glass fiber reinforced top sheet covered with a bitumen flood coat.

Photo 18: Low slope roof at former roof monitor

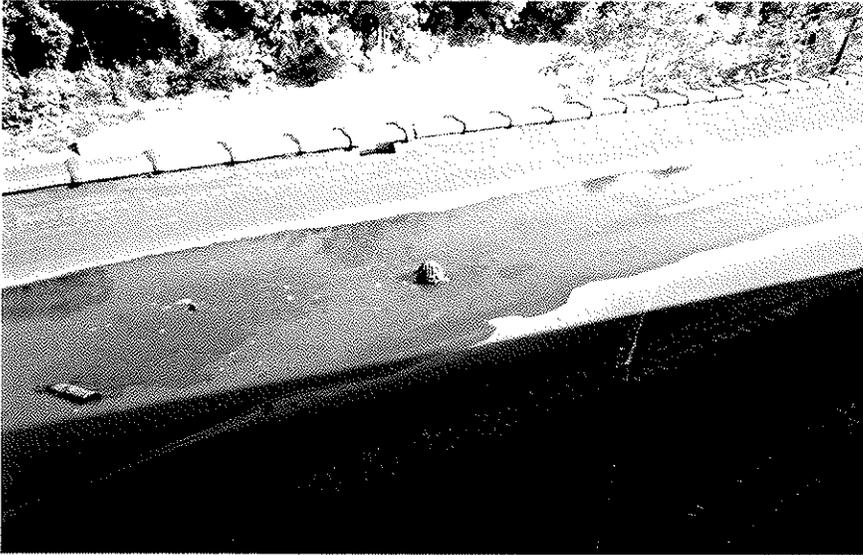
Photo 19 (top): Coping at east façade wall. Note overflow opening and presence of standing water.

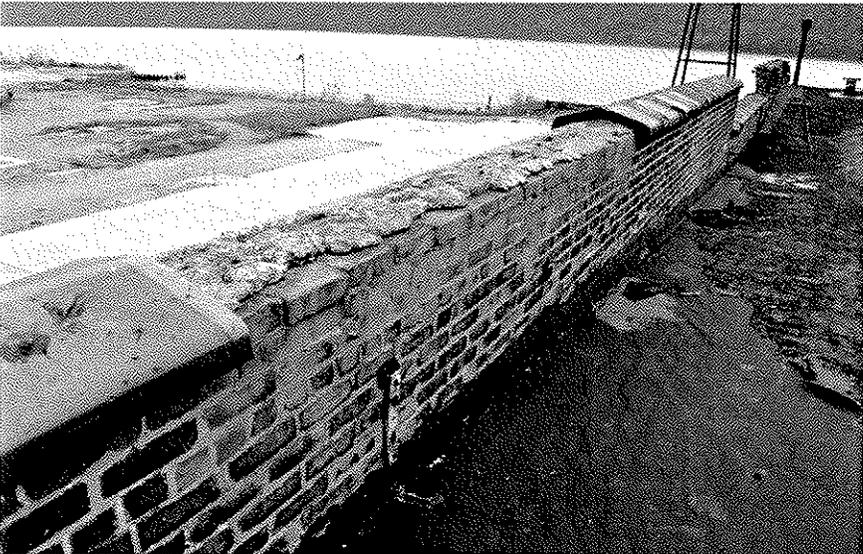
Photo 20 (middle): Coping at south façade wall. Note missing coping.

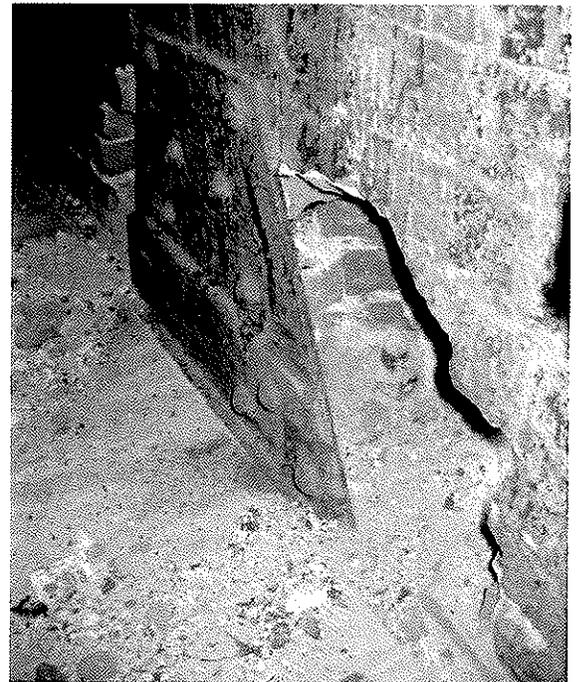
Photo 22: Wall probe #3 - column base

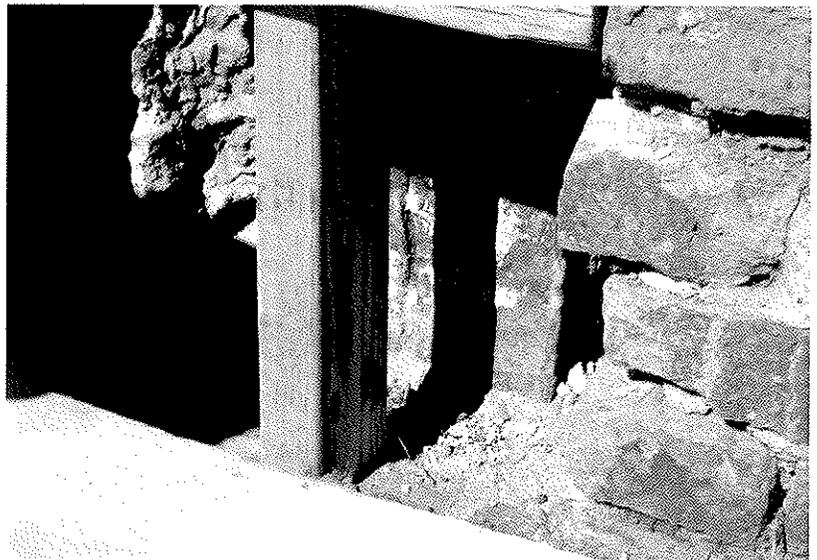
Photo 23: Wall probe #1A - column base

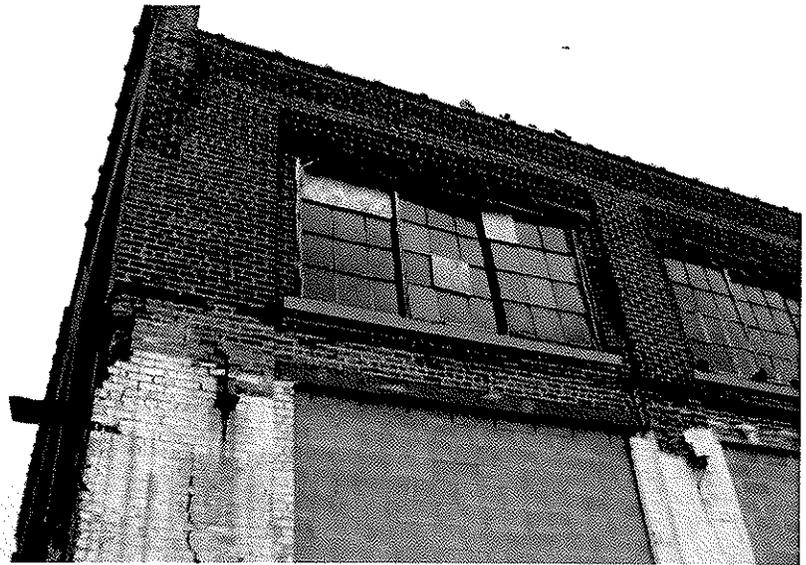
Photo 24: T-shapes at west wall

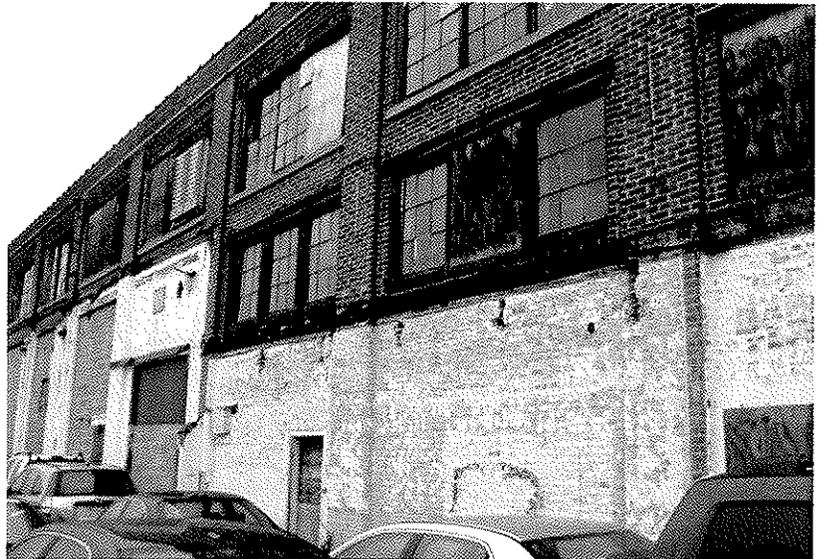
Photo 25: West wall beam pockets and paint

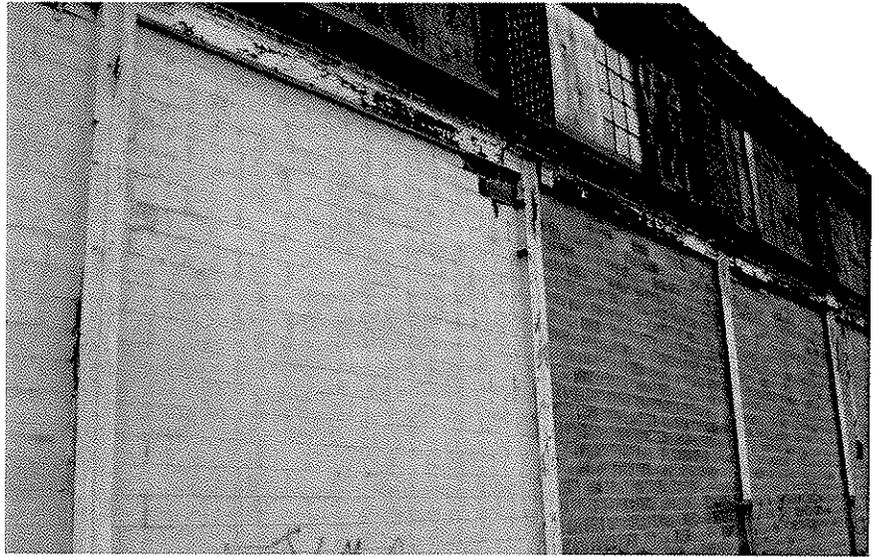
Photo 26 (top): Exposed steel columns at west wall

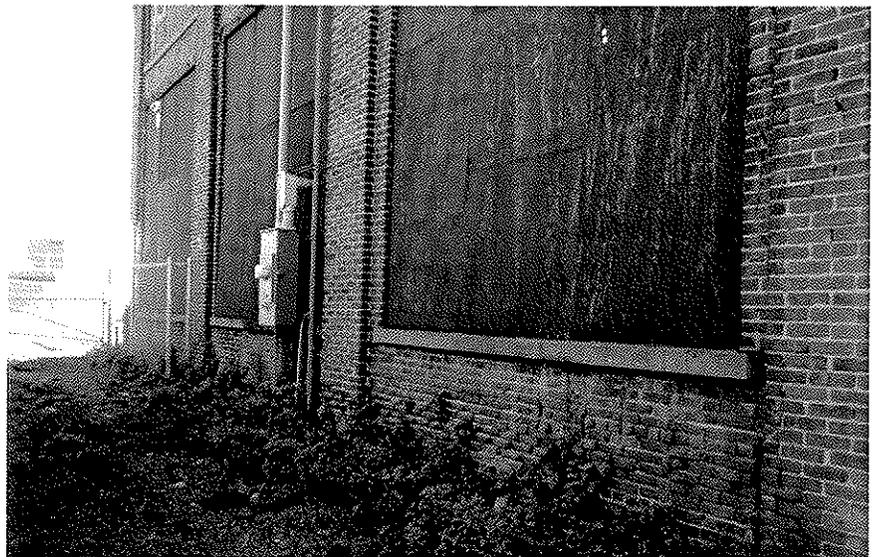
Photo 28 (bottom): Repointing at base of east wall

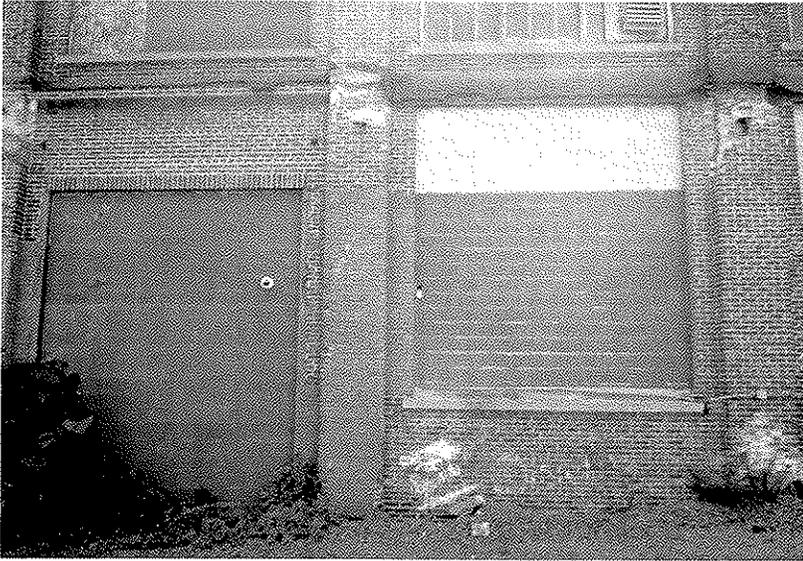
Photo 29: T-shapes at north wall

opportunity to dry out as well as the south or west face. This increased length of moisture exposure may have led to the mortar joints deteriorating more than elsewhere on the building.

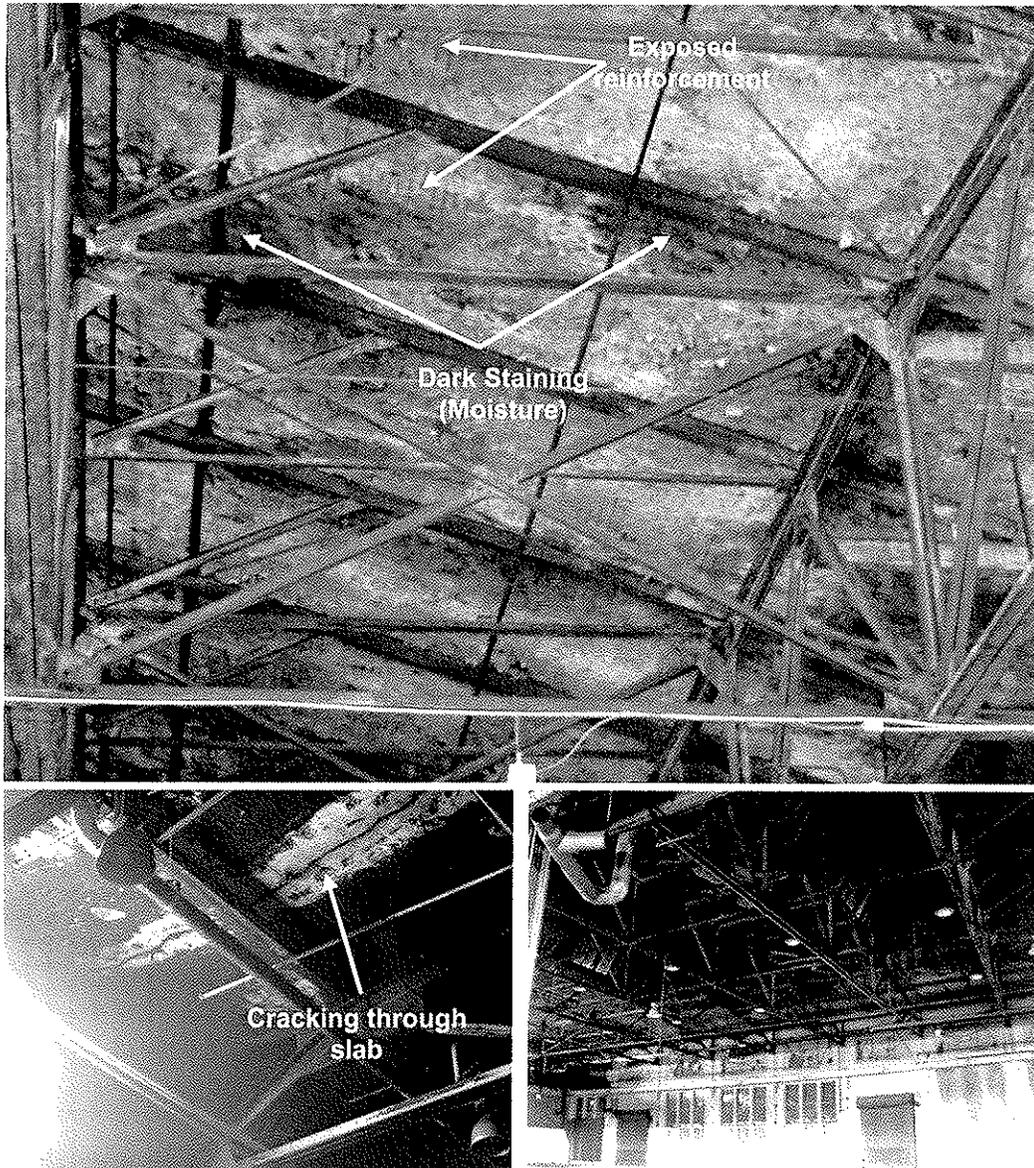
Top – Showing spalling concrete and exposed reinforcement

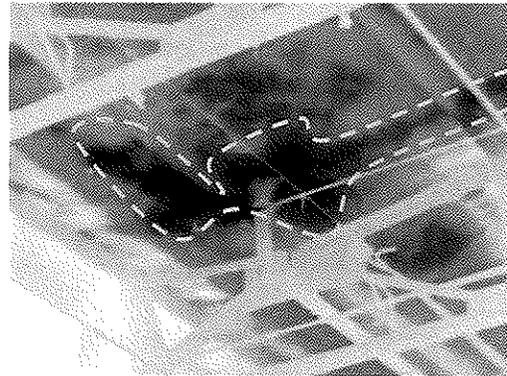
Example Thermal Image – Cooler (darker) responses across the soffit surface revealed increased moisture

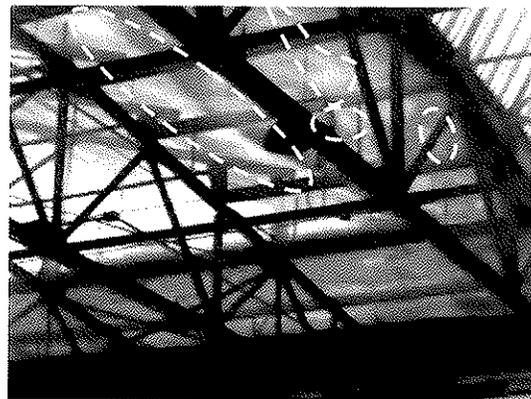
Example Thermal Image - of numerous hotter (lighter) thermal responses that 'could' represent spalling and

As a result of the various analysis considerations explained above, our recommendation is to confirm the accuracy of the thermal imaging results collected during the probing phase. Documentation of probing and ideally localised sounding work in the area surrounding the probes will identify whether delaminating or spalling sections of concrete exists. With this information

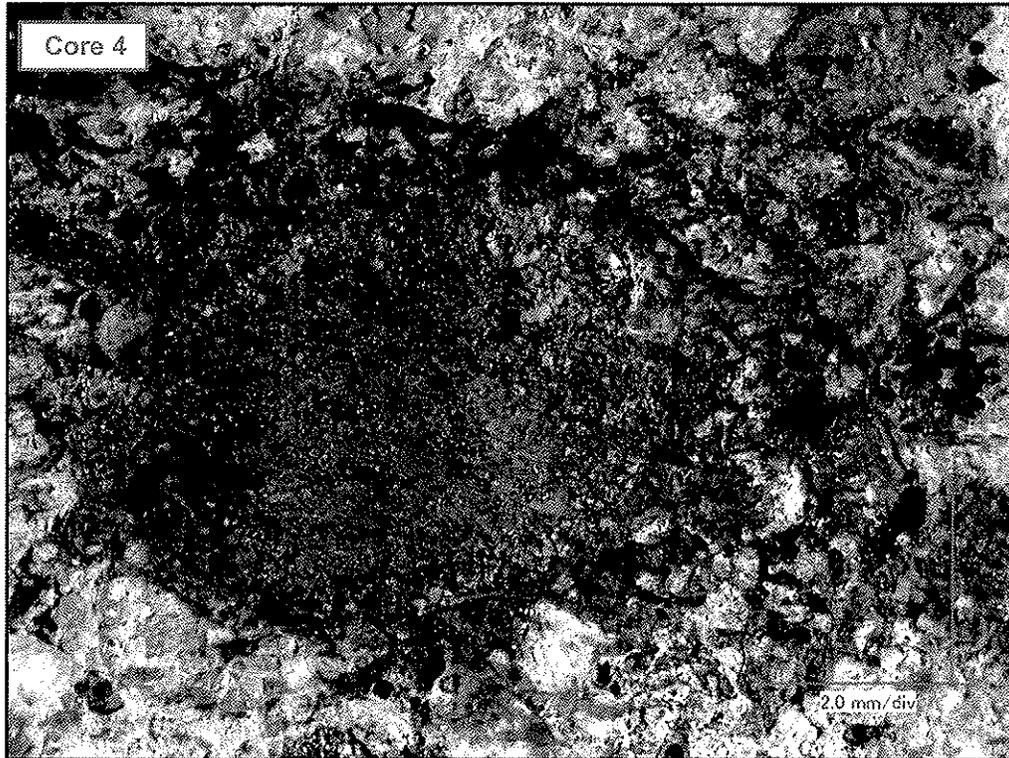
Photomicrograph 13. Close up of corroded wire reinforcing. Corrosion observed in nearby paste.

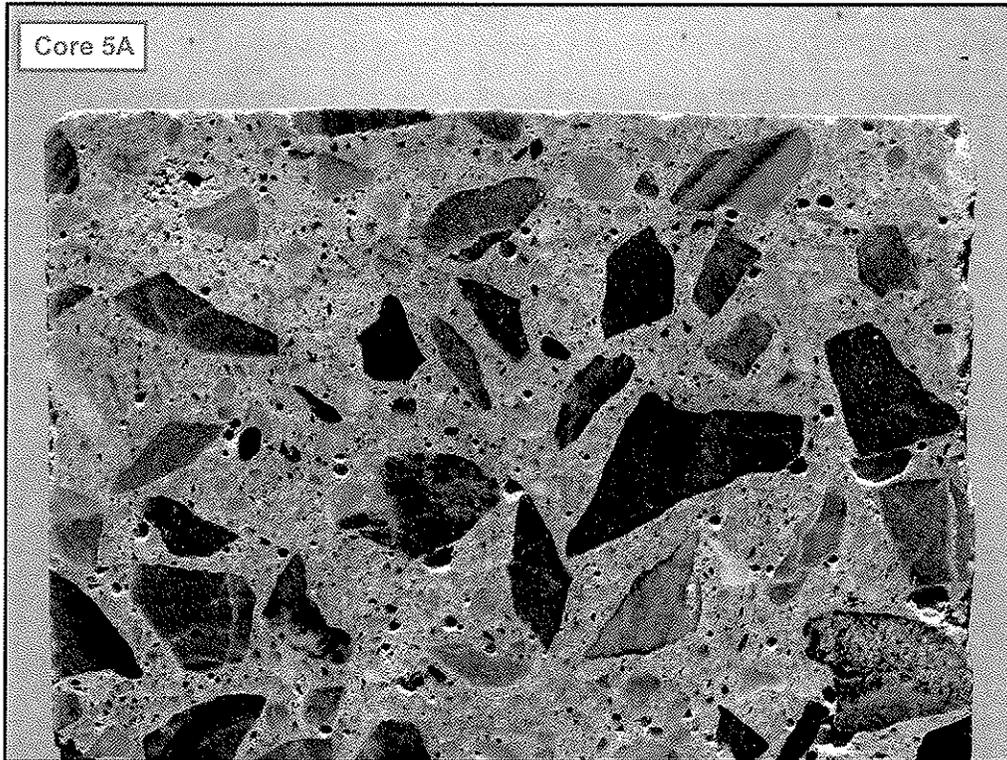
Photo 15. Depth of carbonation approximately $\frac{3}{4}$ to 1" deep.

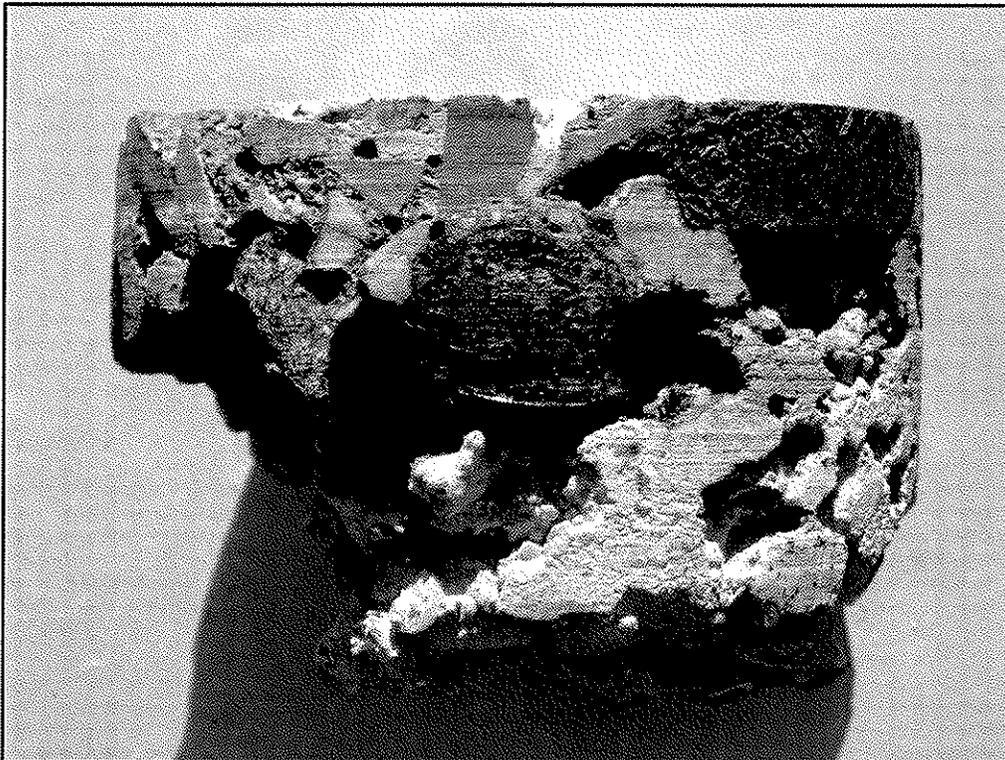
Photo 20. Poor consolidation of concrete observed around reinforcing steel bars.

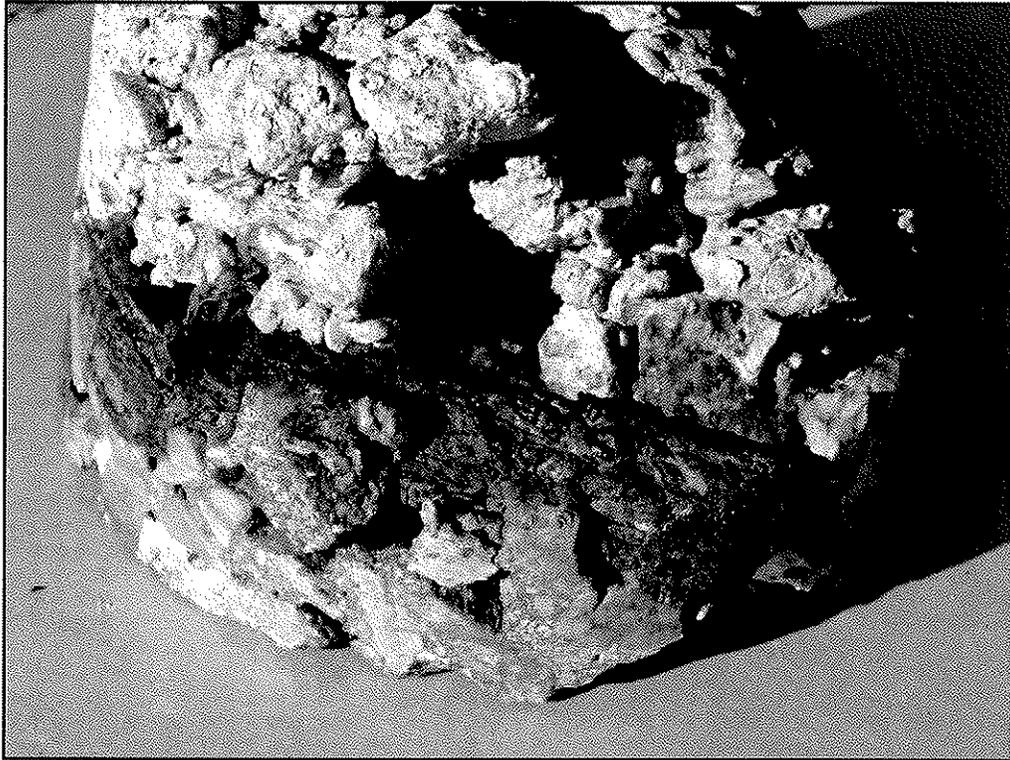
Photo 21. Excessively corroded rebar observed at bottom of core.

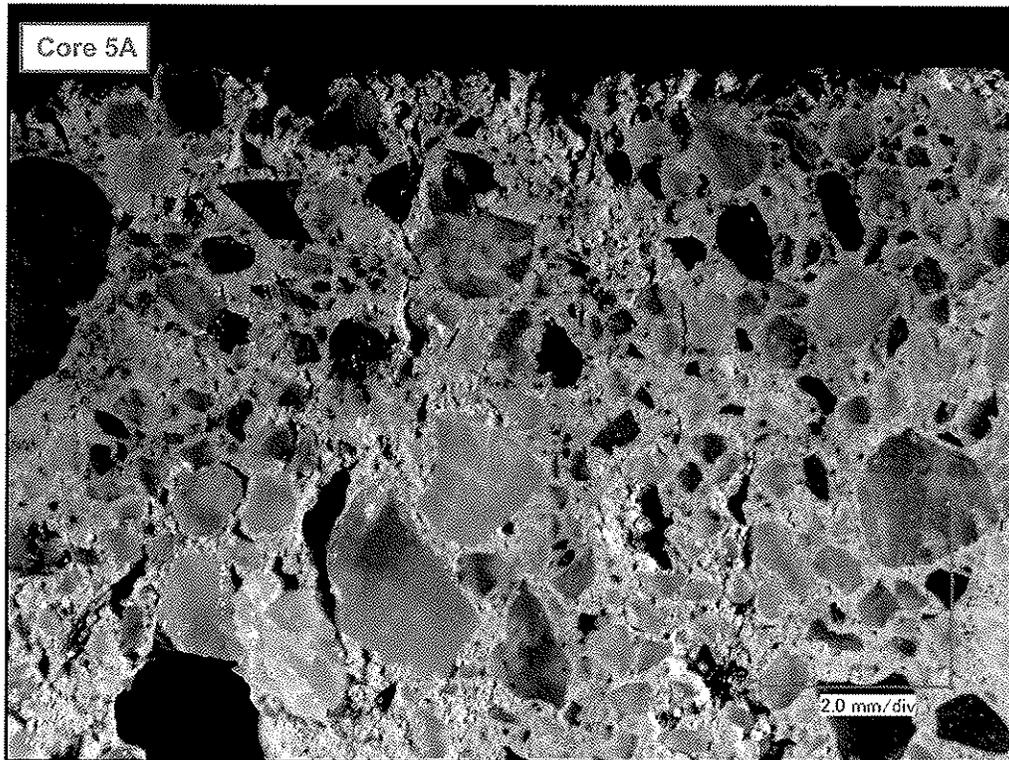
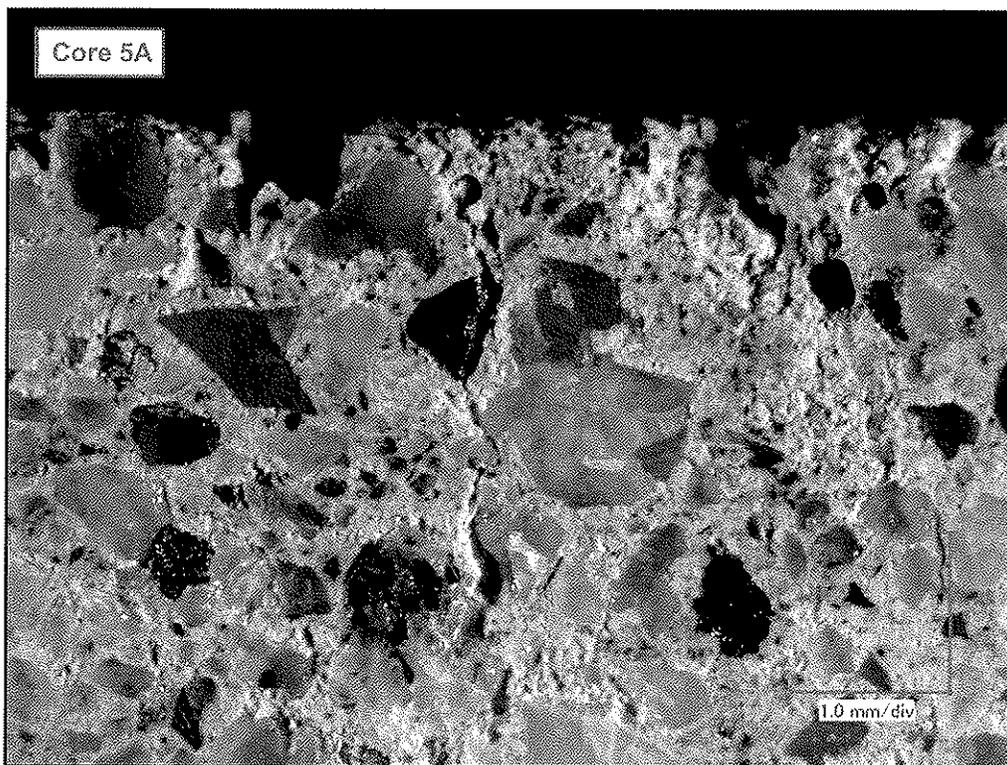
Photomicrograph 25. Vertical cracks observed in Core 5A.

Photomicrograph 26. Vertical cracks observed in Core 5A.
