Re: **Building 52 Engineering Evaluation Report**

Stabilization Evaluation

One River Street
Hastings-on-Hudson, NY

27 May 2011

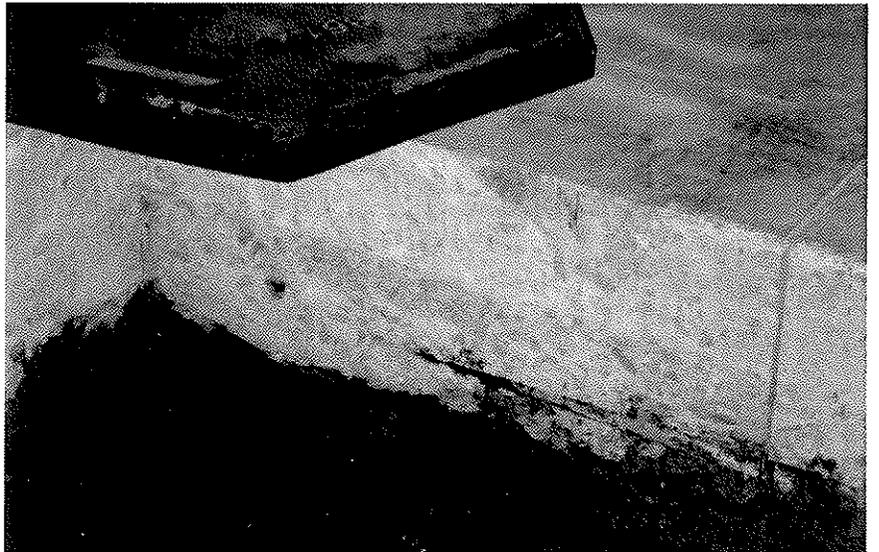
At all probe locations, the concrete appeared to be in good condition. In general, there were no noticeable voids or cracks, nor were there any signs of separation between the paste and aggregate. Probe #4 showed the most signs of poor concrete placement with some voids and separation in the layer of concrete below the reinforcing [photo 5]. The reinforcing typically showed little signs of corrosion, however, at probe 4 the reinforcing had corroded slightly more. This may be a localized problem due to the above-mentioned concrete voids/separation.

Photo 3 (top): Floor probe #2
cross section with reinforcing

Photo 4 (middle): Floor probe #5
cross section with reinforcing

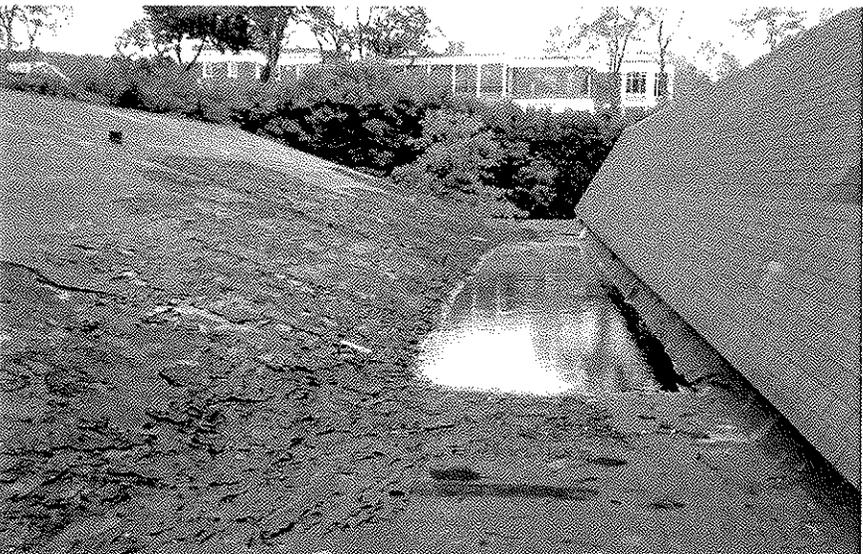
The parapet walls vary in height. At east and west façades, where the coping is just inches above the deck, the membrane terminates beneath the terra cotta coping [photo 19]. At north and south façades, where the parapet height varies between two to three feet above the roof deck, the roof membrane terminates at copper counter-flashing some eight inches above the roof deck. Most of the counter-flashing has been covered with successive layers of roofing mastic.

At east and west façade parapets, there are two shapes of terra cotta coping, both 16 inches wide, suggesting some coping units are replacements. At north and south façades, the terra cotta coping is 20 inches wide [photo 20]. The brick mortar joints on the roof side of these parapets are eroded. Coping is loose or missing at all parts of the building.

Photo 19 (top): Coping at east façade wall. Note overflow opening and presence of standing water.

Photo 20 (middle): Coping at south façade wall. Note missing coping.

The existing roof membrane, including perimeter and penetration flashings, cannot be effectively repaired. Roof replacement is mandatory. One approach to roof replacement first requires the total removal of the existing membrane system. This would then allow a detailed inspection and repair of the concrete decking before application of a new roof system. However, this approach is very expensive and is not required in order to stabilize the roof enclosure.

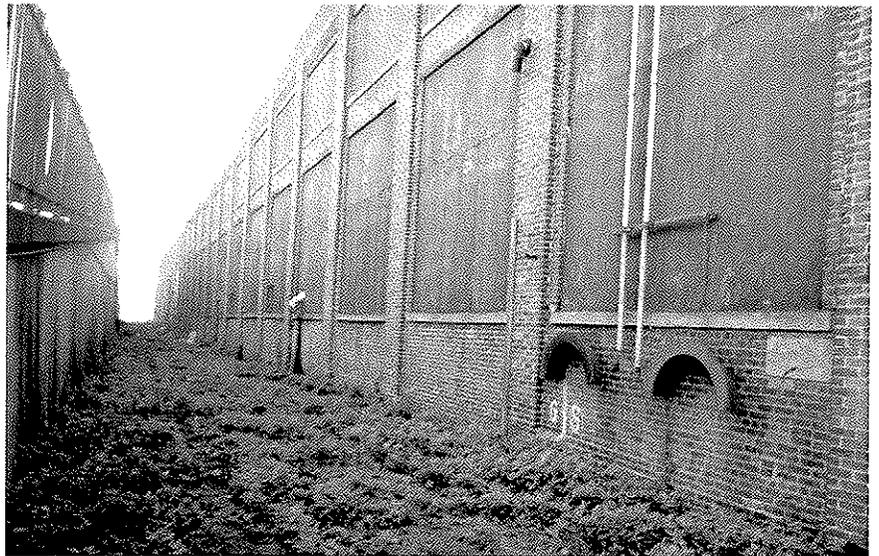
Photo 26 (top): Exposed steel columns at west wall

Photo 27 (middle): East wall windows

The last portion of the west wall (grid 23-37) had various exposed steel columns and painted CMU [photo 26]. In order to stabilize the building from further deterioration, it is recommended that all exposed steel (this includes steel lintels at all openings) be scraped and painted and that all CMU have existing paint removed and a breathable sealant be applied. There are also many areas over the surface where masonry needs to be repointed, or even replaced, and where other objects, such as conduit, should be removed (see drawing S-100 for full scope of work).

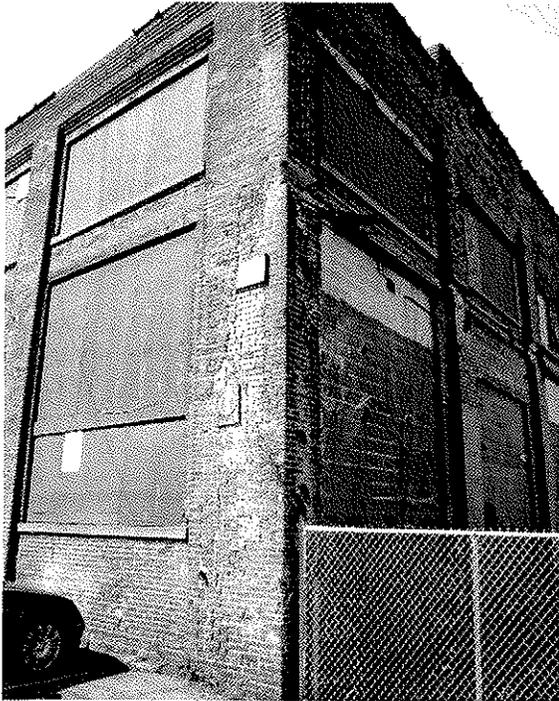
Photo 30: Southeast pilaster

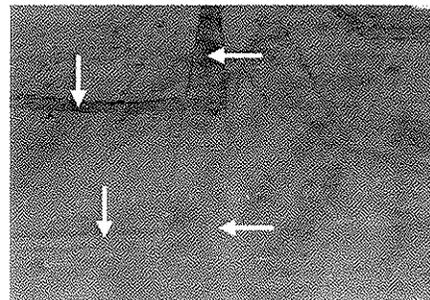
The overall floor slab construction is similar throughout; however variations in thickness and reinforcement placement were identified, which tend to relate to concrete filled service / pipe trenches (typically visible at the surface), repaired sections of slab (again typically visible at the surface), possible machine bases, changes in construction and likely pile cap locations beneath.

Visible service / pipe trenches

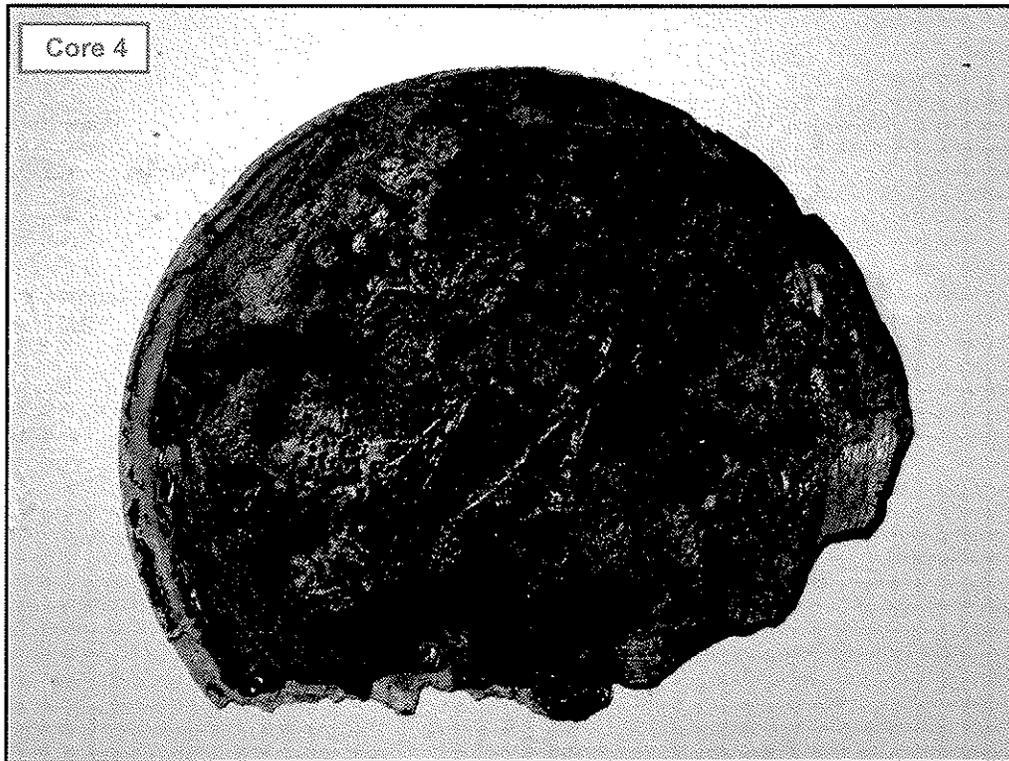
General: The side of the core was labeled by others in its as received condition. The labeling indicated that the top of the core was at the end closest to the wire reinforcing inclusion. This appears to be incorrect. We observed a roof membrane on the top of one sawn end portion (Photo 3). The roof membrane indicates the top surface of the core. Beneath the roof membrane the paste of the concrete is a light tan (Photo 4). This light tan paste could be matched up with paste at the end of the core labeled as the bottom. This did not match the paste labeled as the top. As a result the sample appears labeled incorrectly. Also, it is not often that wire reinforcing is located so close to the top surface. It is typically located near the bottom of the slab. Our report will note that the end closest to the wire reinforcing is the bottom.

Photo 3. Roof membrane observed on top surface of Core 4.

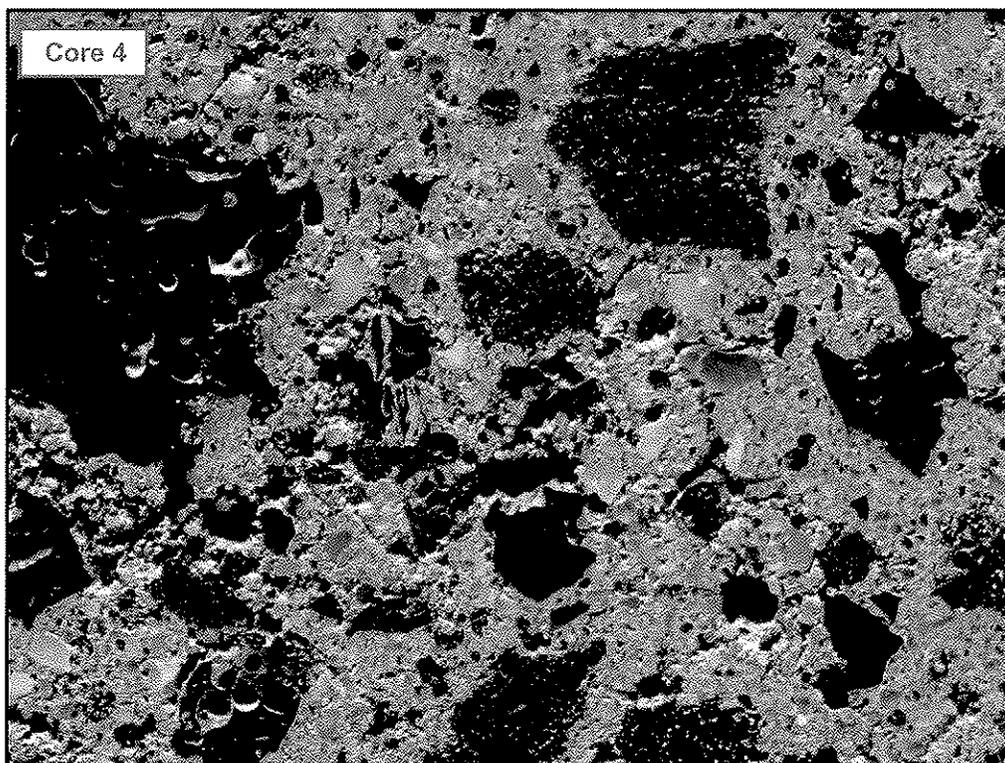
Coarse Agg: The coarse aggregate was a lightweight aggregate comprised of boiler slag and bottom ash (Photo 5). Boiler slag and bottom ash were commonly used to produce lightweight concrete prior to the development of the modern lightweight shale and clay aggregates. The maximum aggregate size typically appeared to be approximately $\frac{3}{4}$ "", but we observed a 2" lightweight aggregate at the side of one core. The surfaces of the coarse aggregate varied from angular to subrounded. The coarse aggregate particles were typically equidimensional in shape. The coarse aggregate was evenly distributed in the cores with no indications of segregation. We observed some paste with the voids of the lightweight aggregate (Photo 6). This is an indication that the lightweight aggregate was not adequately saturated prior to mixing. We did not observe indications of deleterious aggregate reactions.

Photo 5. Boiler slag and bottom ash lightweight aggregate observed in Core 4.

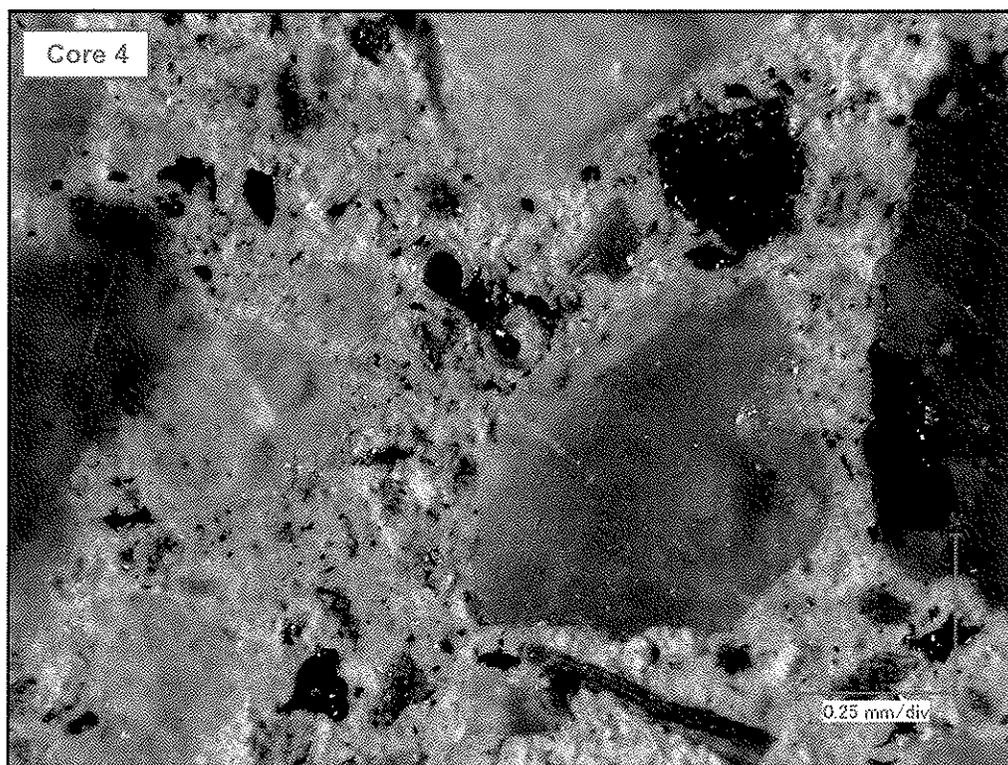
- Paste:* The matrix does not appear to contain supplemental cementitious materials such as fly ash or slag. We observed some occasional particles resembling fly ash cenospheres, but these were likely from the bottom ash lightweight aggregate (Photo 8). The paste of the concrete was very soft as it could be easily scratched and gouged with a steel point. The paste also eroded significantly during sample preparation (Photo 9 & 10). We estimate the water to cement ratio to be in the range of 0.60 to 0.65. The porosity of the paste varied, but generally appeared to be high. The soft eroded paste appeared to simply be a result of a high water cement ratio and not some form of deterioration such as aggregate reactions or chemical attack.

Photomicrograph 8. Fly ash cenospheres observed in paste.

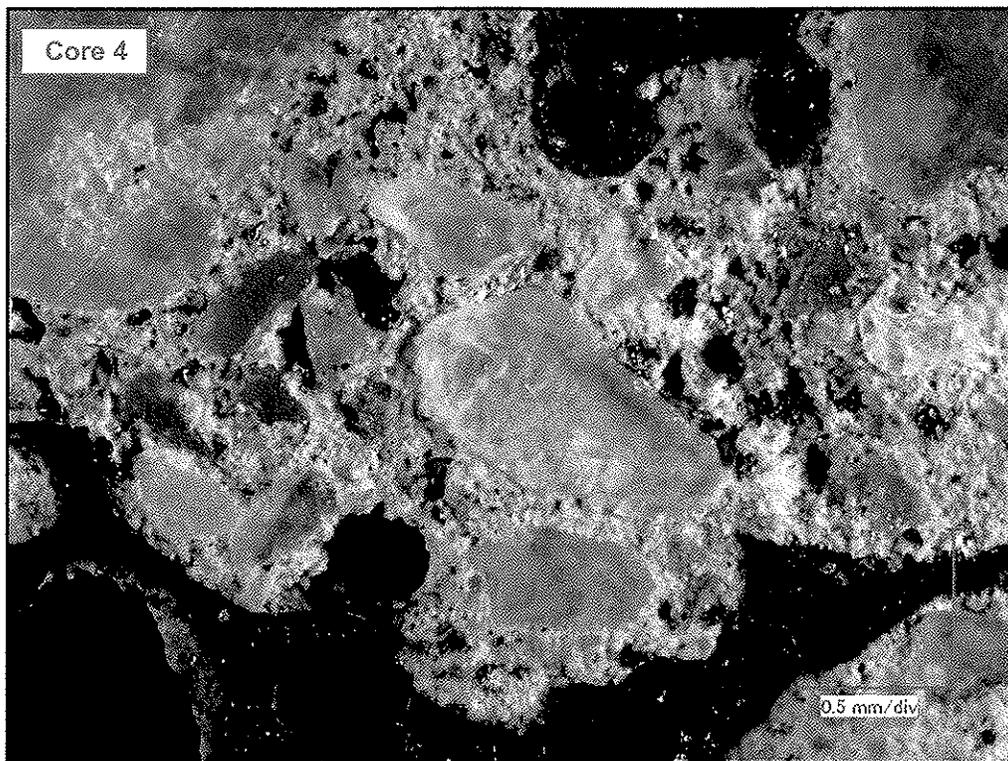
Photomicrograph 9. Eroded paste observed in Core 4.

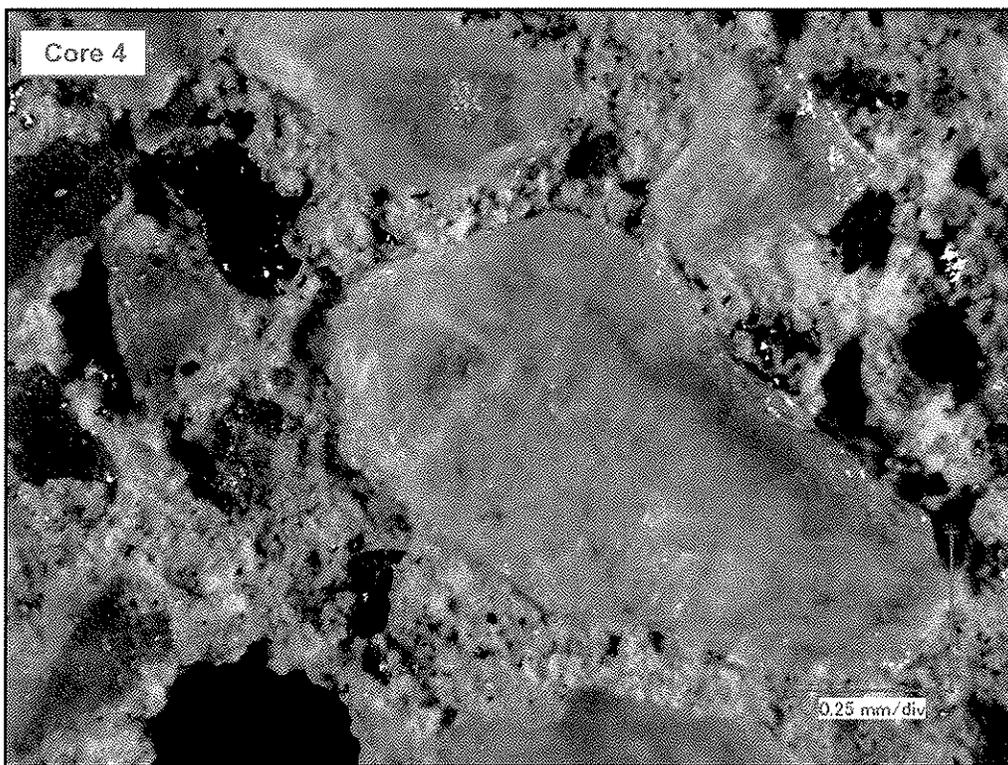
Photomicrograph 10. Eroded paste observed in Core 4.

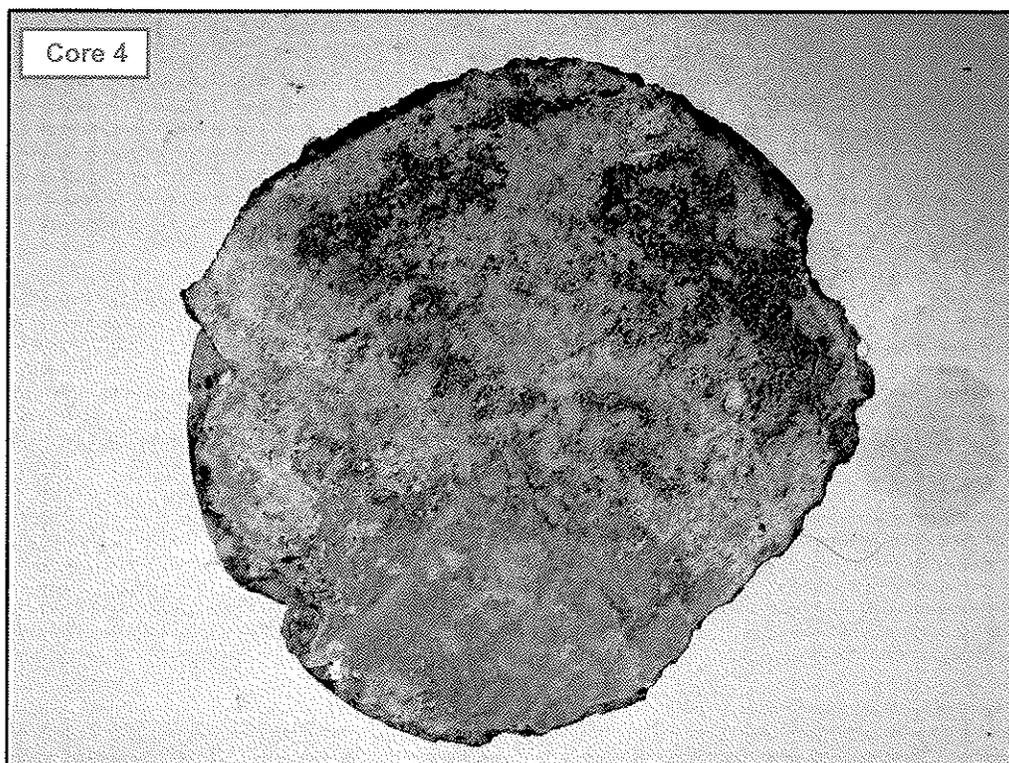
- Surfaces:* As mentioned previously the ends of the core were sawn, but both thin portions were saved. A black roof membrane material was observed on the top surface of the core. The thickness of the membrane varied from approximately 1/16" to 3/16" thick. The bottom surface of the core was difficult to interpret. It did not appear to be wood formed (Photo 11). The bottom surface also appeared to have been painted 2 or 3 different colors.

Photo 11. Bottom surface of Core 4.

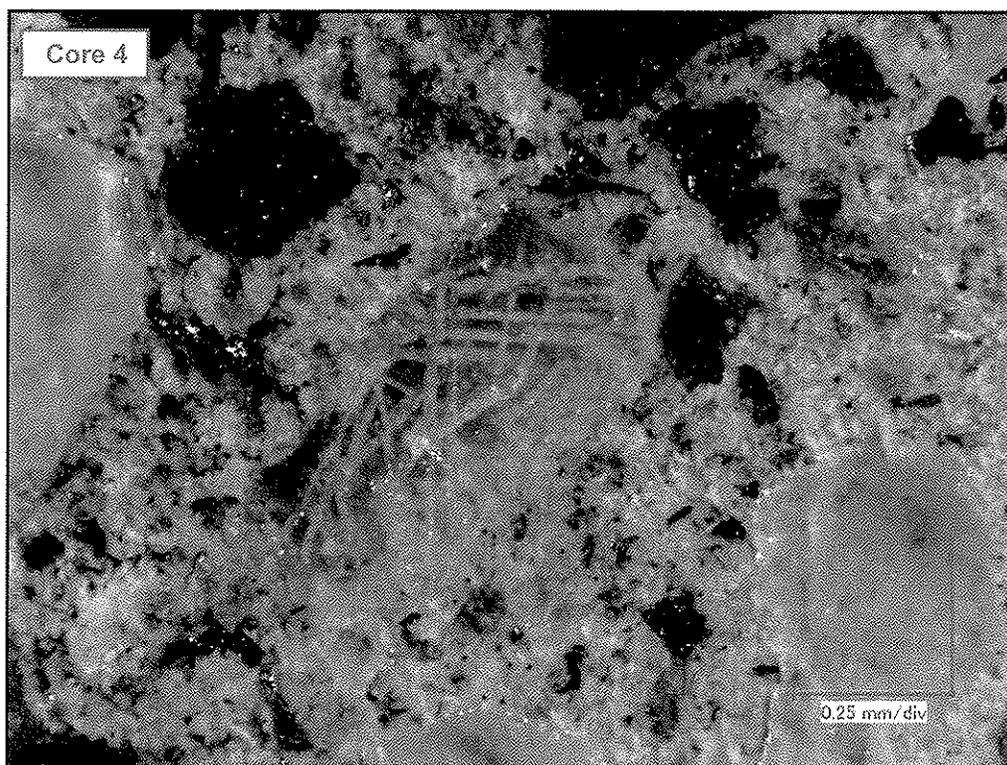
Photomicrograph 12. Secondary deposits observed within void.

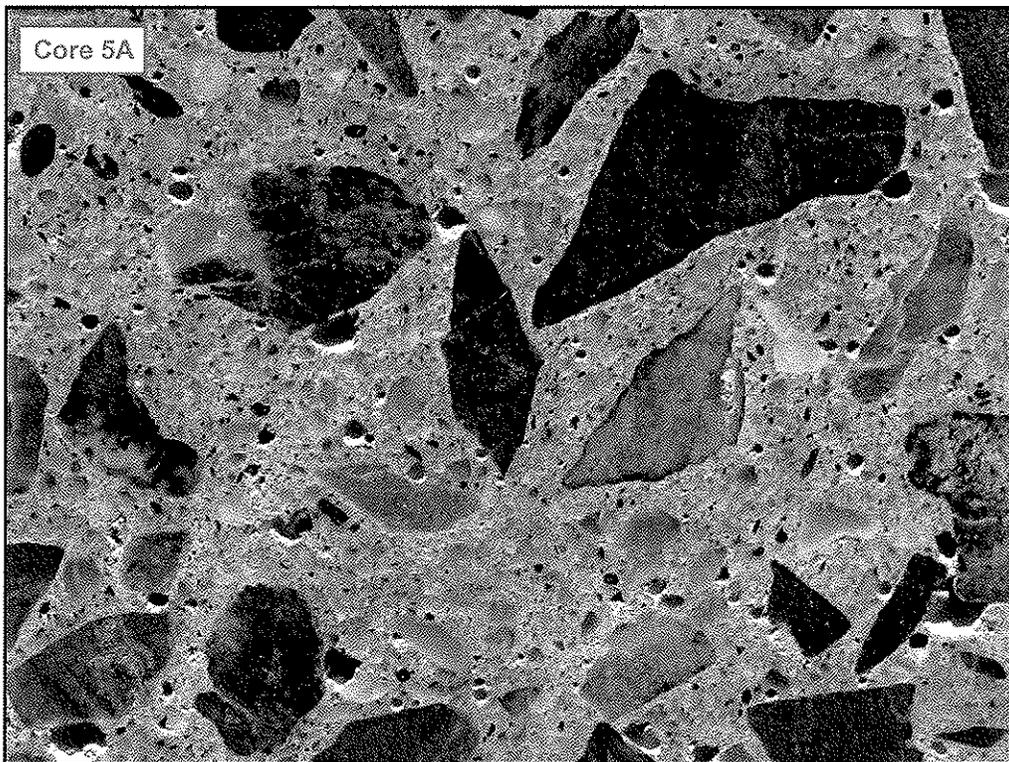
- Paste:* The matrix (hardened cement paste) of the cores varied significantly in coloration. The majority of the middle portion of the core was gray, but the gray coloration was not uniform. Zones of relatively darker and lighter gray paste were observed (Photo 14). This is a result of not thoroughly mixing the concrete and is not uncommon in concrete from this era. The non-uniform paste coloration however, does not appear to have significantly affected the strength of the concrete (5380 psi AVG). Additionally, the upper 1/2 to 3/4" of the paste was light tan in coloration (Photo 15). This is a result of carbonation. If we add the approximate 1/4" missing from the top surface the depth of carbonation is approximately 3/4 to 1" deep. This amount of carbonation is excessive and is likely a result of the manufacturing process of the factory. Utilizing phenolphthalein staining we confirmed that the carbonation ended at the transitions from tan to gray paste. We also observed isolated light tan zones within the middle of the core and near the bottom surface. The isolated zone of carbonation within the middle of the core appears to have been a result of interconnected voids providing a pathway for the carbon dioxide beneath the slab (Photo 16).

Photo 14. Uneven distribution of paste color observed.

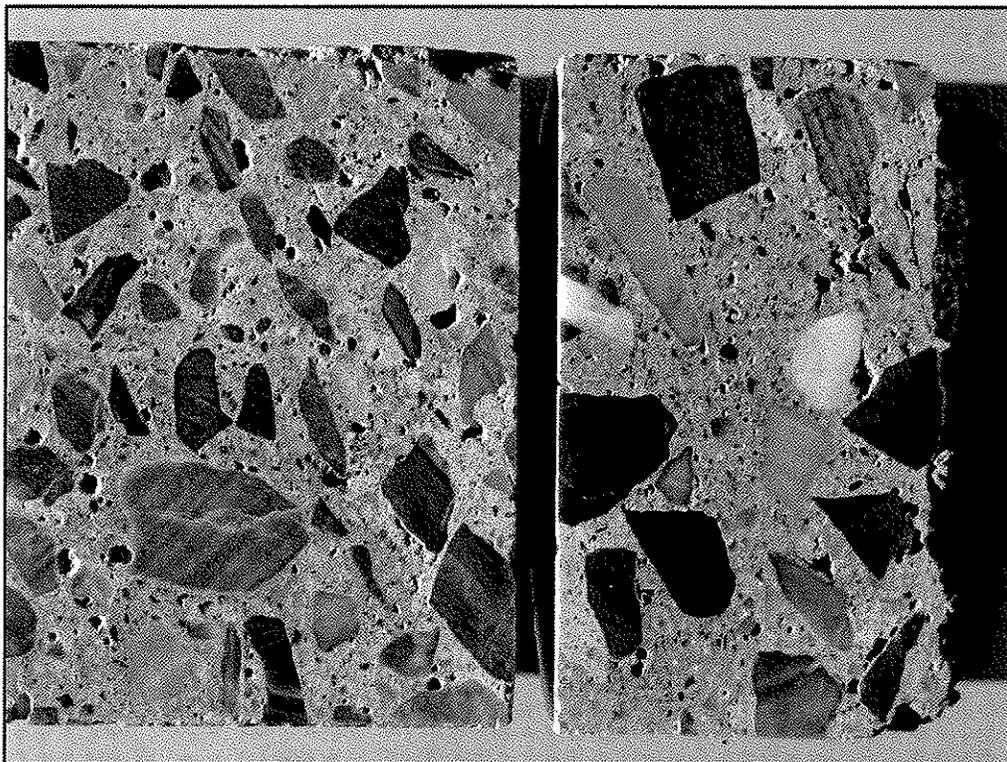
Photo 16. Isolated zone of carbonated paste observed within Core 5A.

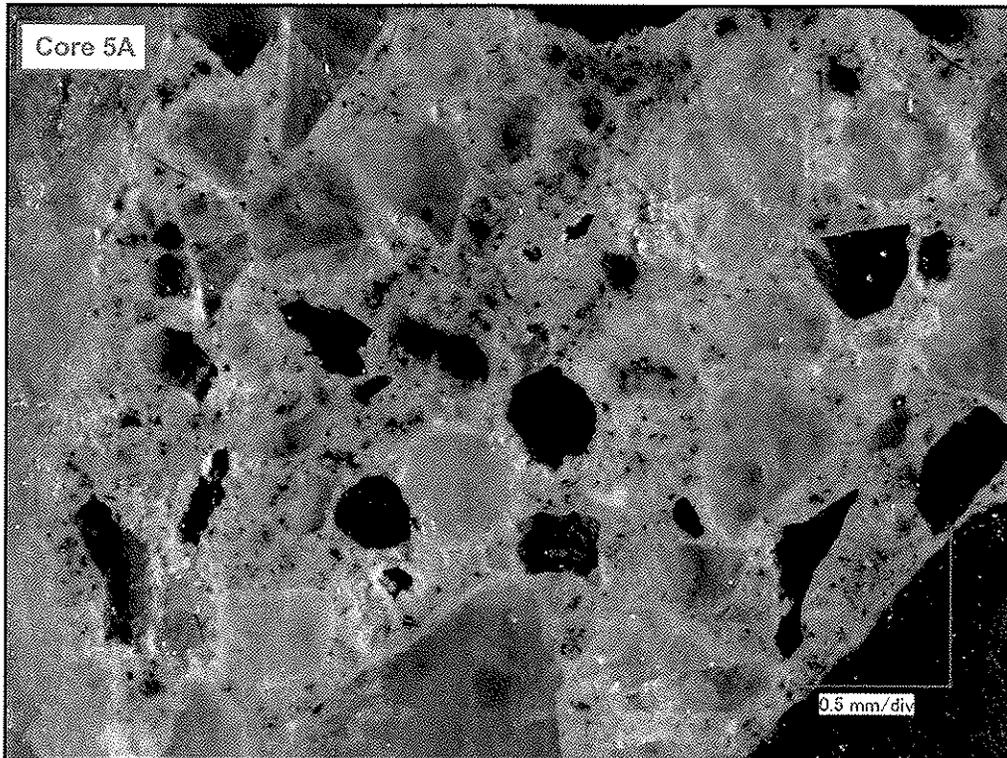
Photomicrograph 17. Paste of floor slab Core 5A.

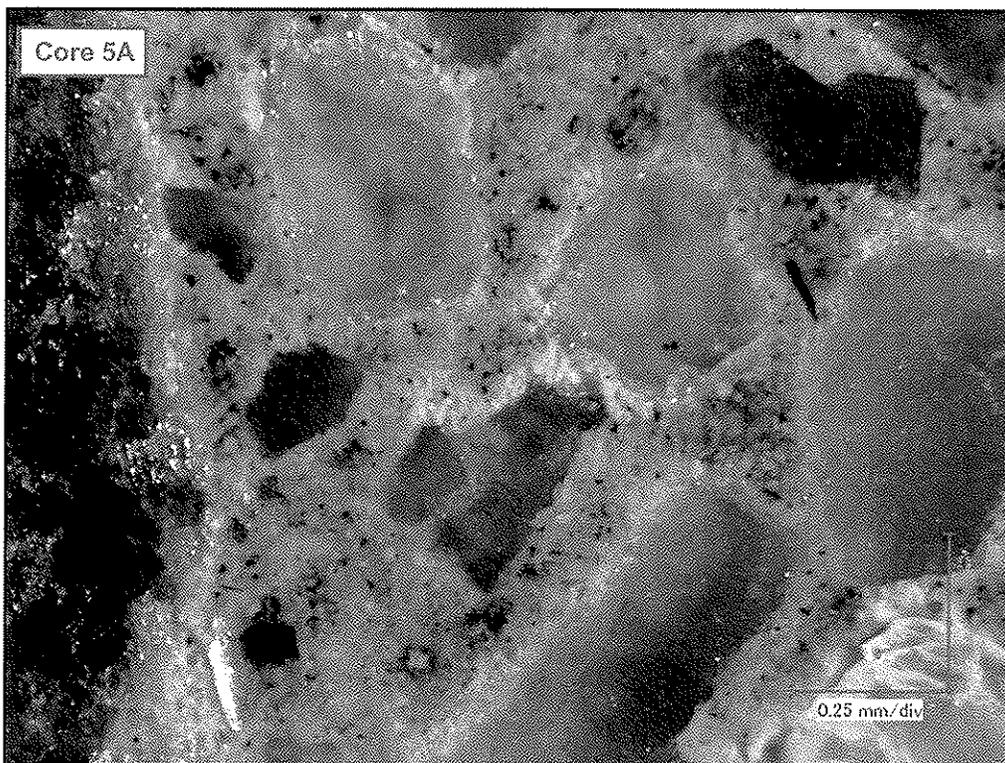
Photomicrograph 18. Paste of Floor slab Core 5A.

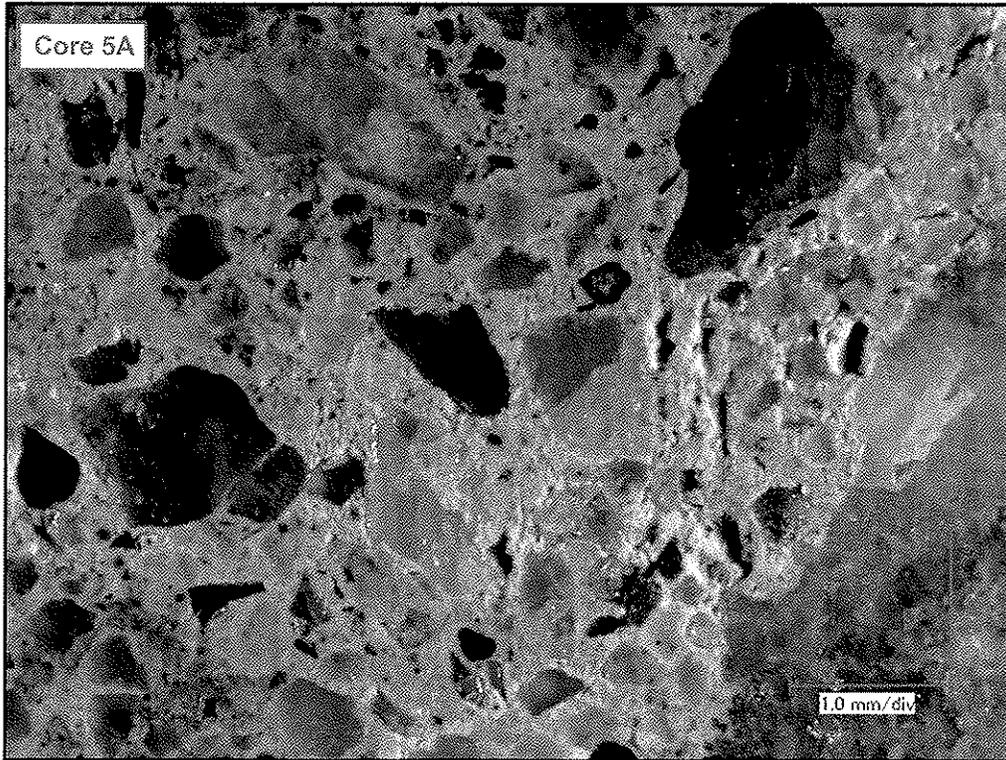
Photomicrograph 19. No entrained air voids observed in Core 5A.

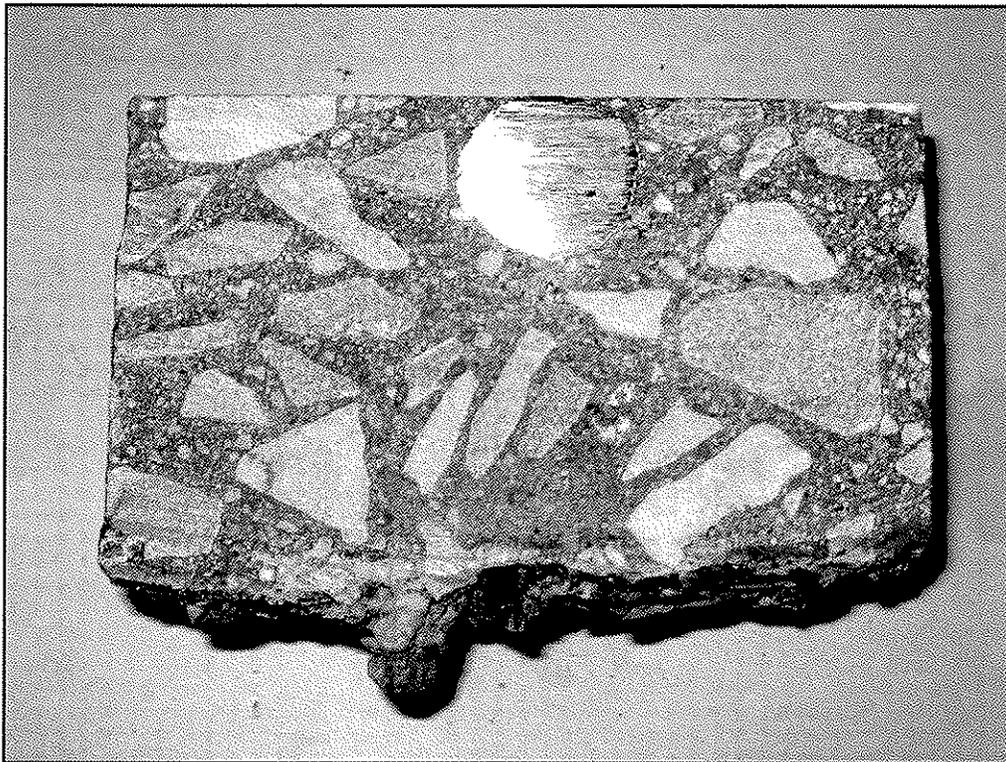
Reinforcing: We observed a steel reinforcing bar at the side of the core with approximately 1¼" bottom surface cover. ACI recommends 3" of cover for concrete placed against a subgrade. The rebar was not included in the polished section. The reinforcing bar appeared to be a #6 bar and showed signs of significant corrosion. The corrosion bleed into the nearby paste, but had not produced cracking in the concrete. The bottom portion of the other floor slab cores also contained reinforcing with excessive corrosion. The corrosion in these cores has progressed to the point of producing exfoliation (corrosive layering) of the steel (Photo 21). The excessive corrosion in the other cores is a result of the reinforcing not being embedded within the concrete. The diameter of the bars with excessive corrosion is approximately 0.6". The diameter of a clean bar with no corrosion was measured to be 0.75" (Photo 22). This indicates either significant section loss in the corroded bars or different bar sizes.

Photo 22. No corrosion observed in steel, paste stained with phenolphthalein (pink staining = high pH).

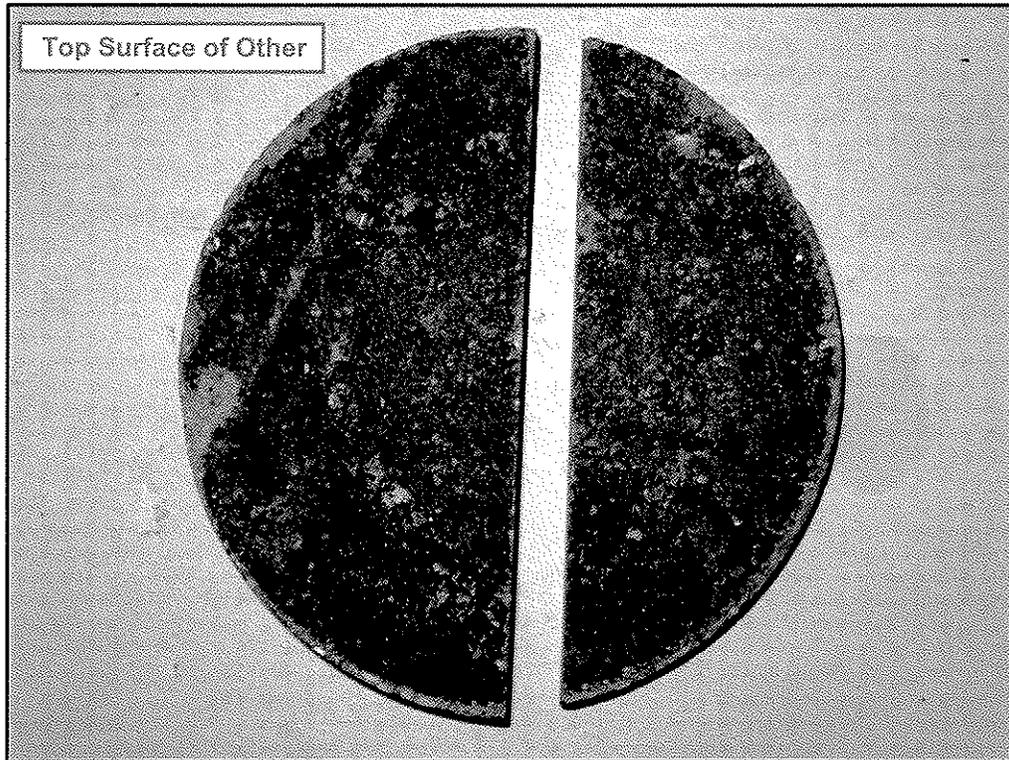
Surfaces: The top surface of polished core was sawn, but we observed the remaining top portion of another floor slab core. Indications of minimal surface erosion were observed, but the top surface generally appeared to be in good condition considering the age and previous use (Photo 23). This top portion from another slab core was cut perpendicular to the top surface and polished (Photo 24). The portion was approximately ½" thick. We did not observe indications of freezing damage, cracking or other detrimental microstructural features. The bottom surface appeared to have been placed on a stone base.

Photo 23. Top surface of other core.

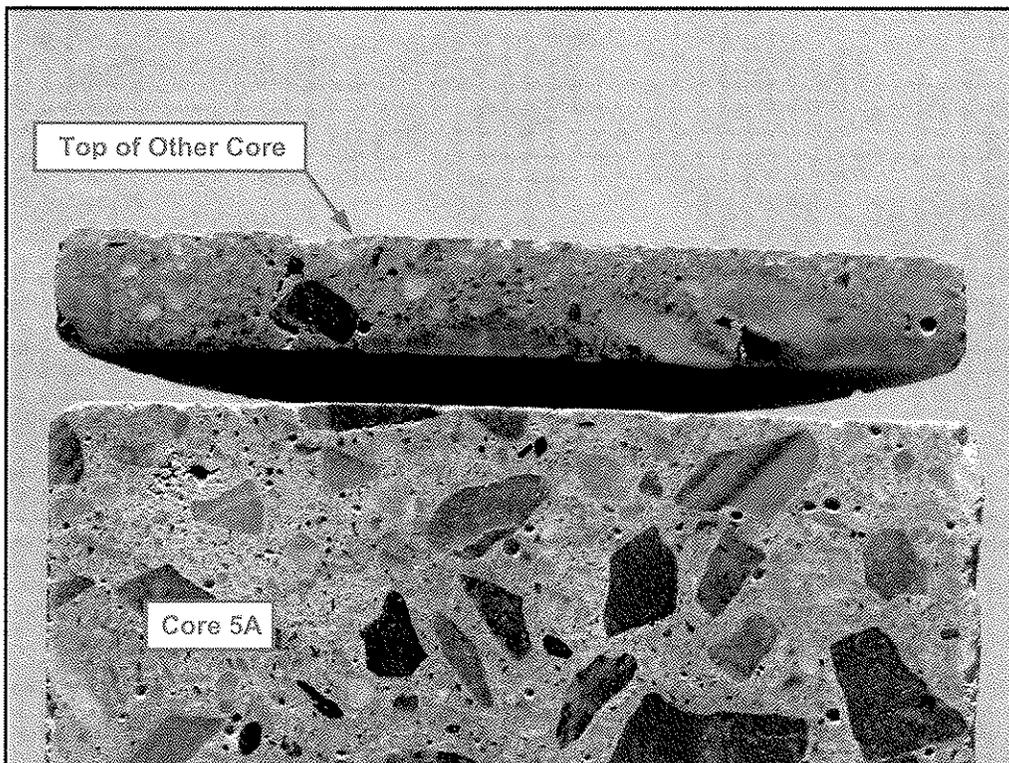
Photo 24. Polished section obtained from top 1/2" of other floor slab core.
